Lightning Protection Systems for Churches & Houses of Worship

Lightning Protection Institute

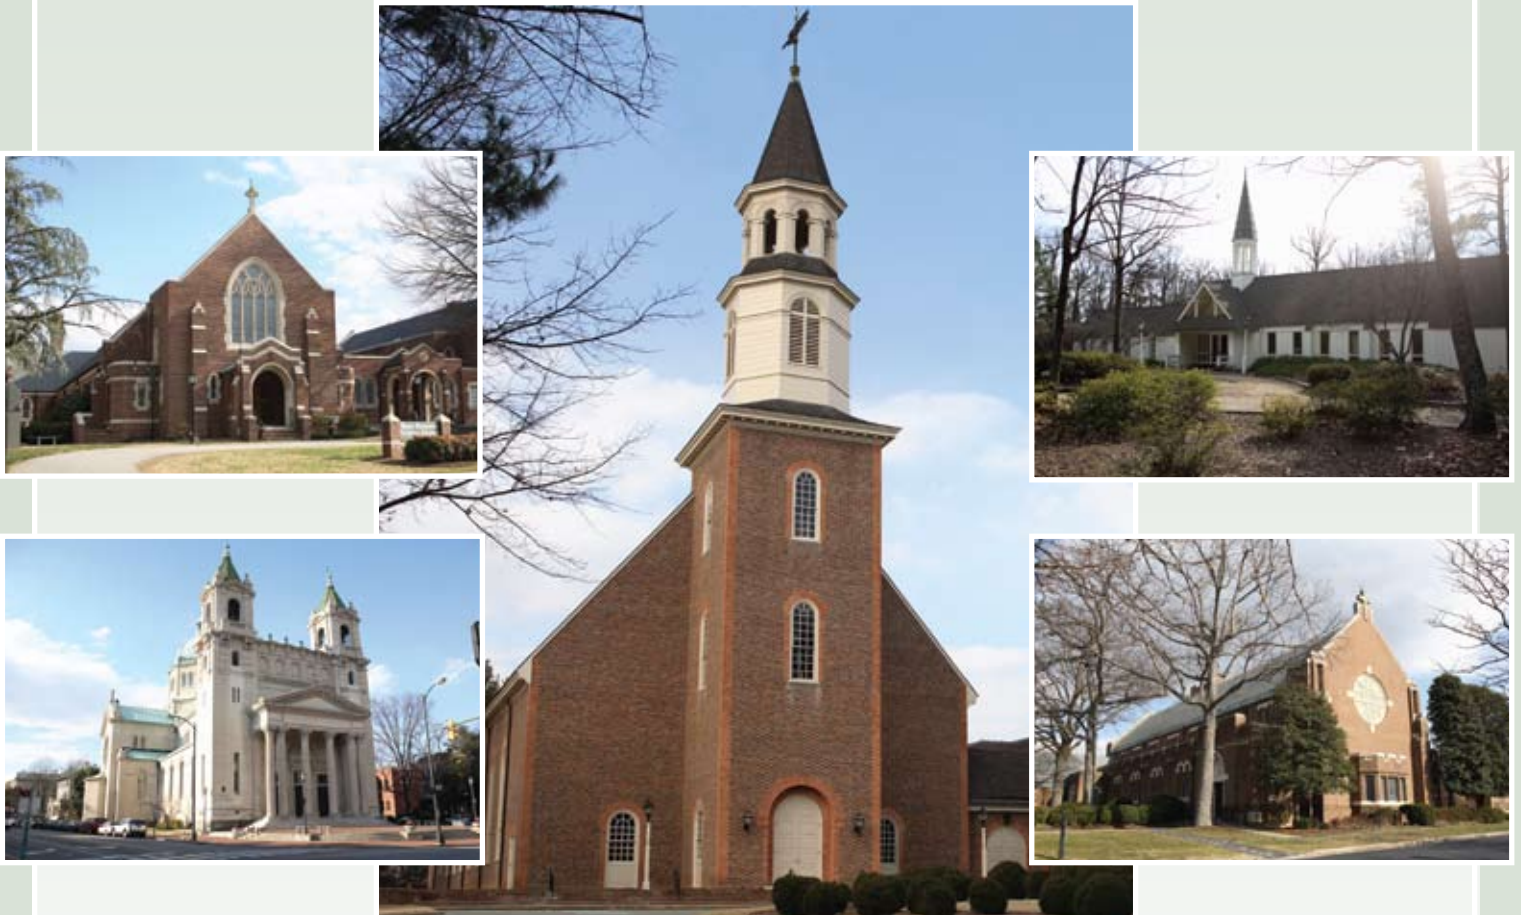
Front Cover:
Note: These churches are equipped with lightning protection systems, barely visible to on-lookers.

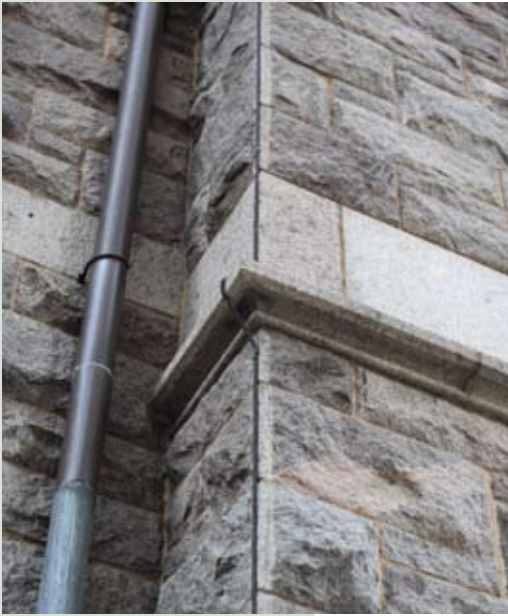
Above:
A close-up of down conductor installed for this church shows how inconspicuous lightning protection can be when properly installed.

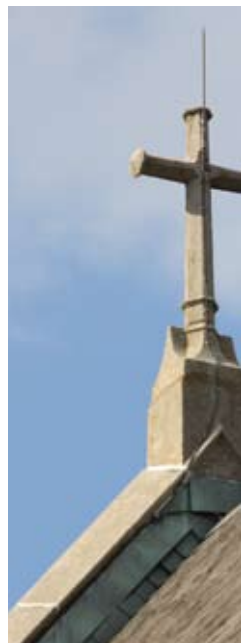
Above:
Components must be UL-listed and labeled for lightning protection use.

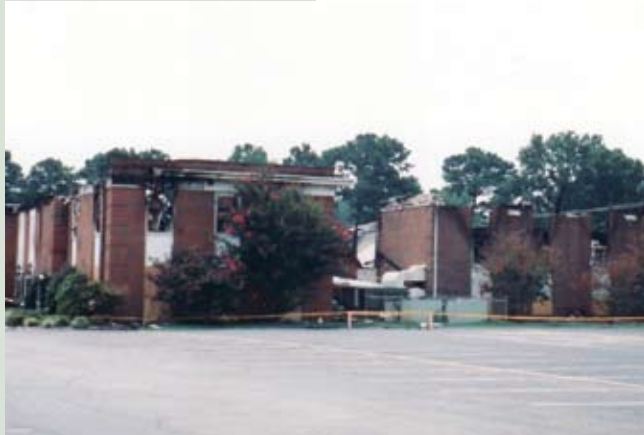
Above:
Lightning fires commonly start in the steeple, roof or attic. A direct lightning strike destroyed the entire roof of this church in Mechanicsville, Virginia.
